Situation Photo Log

Monday, April 30, 2012

Kalamazoo River / Enbridge Spill

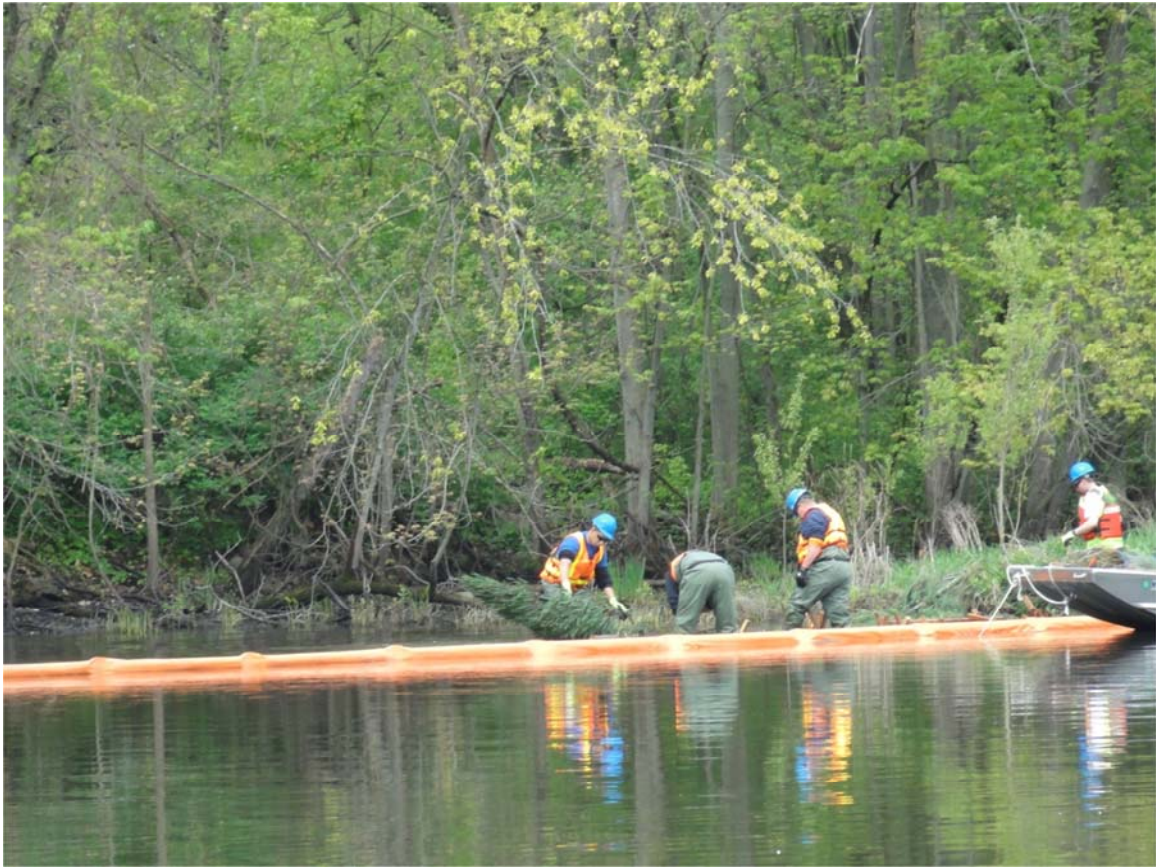
1. MP19.25, observed crews installing the sediment trap.

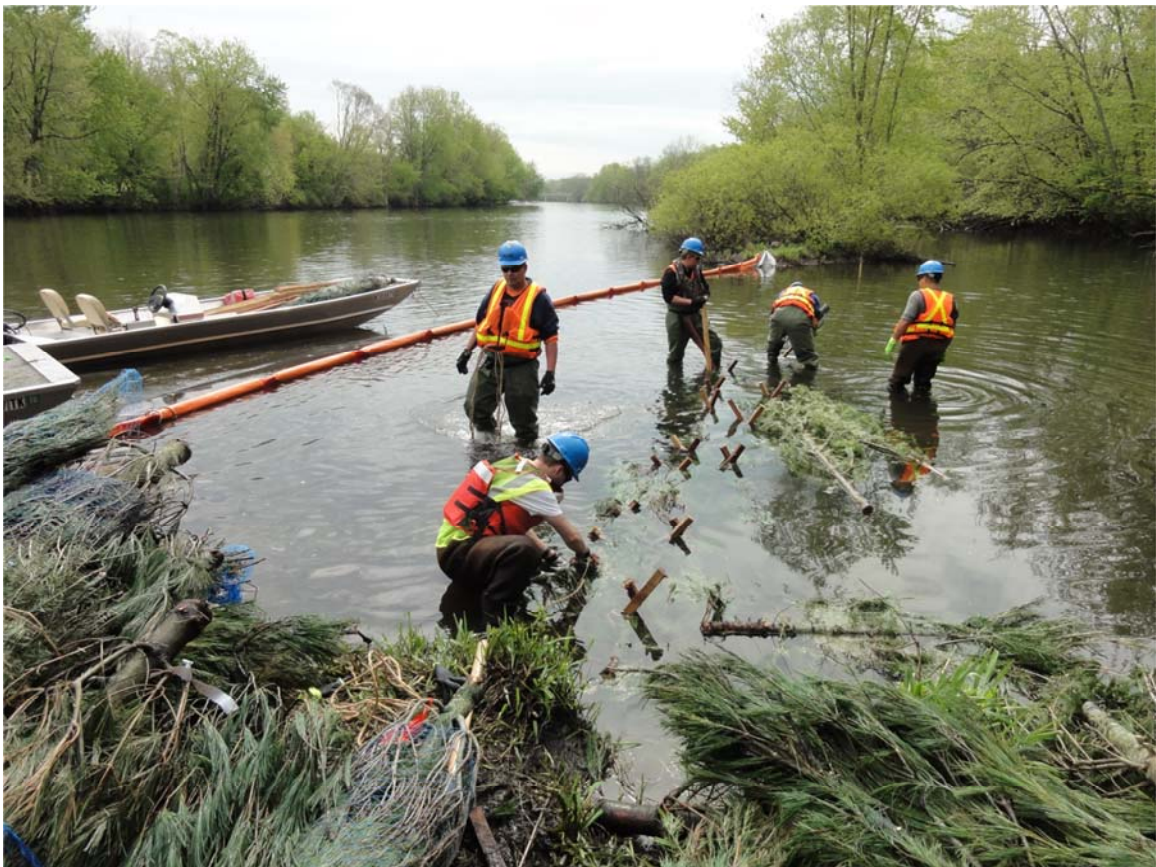
2. MP19.25, observed crews installing the sediment trap.

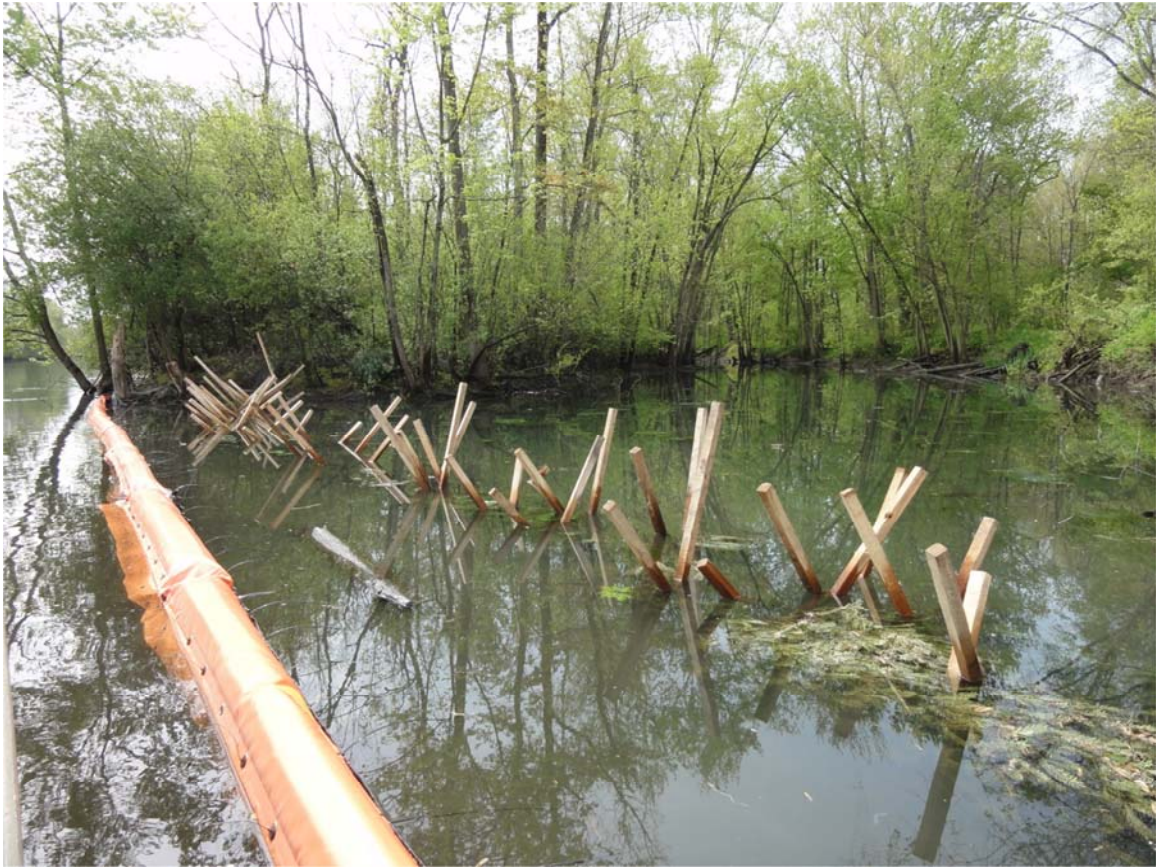
3. MP19.25, installed sediment trap.

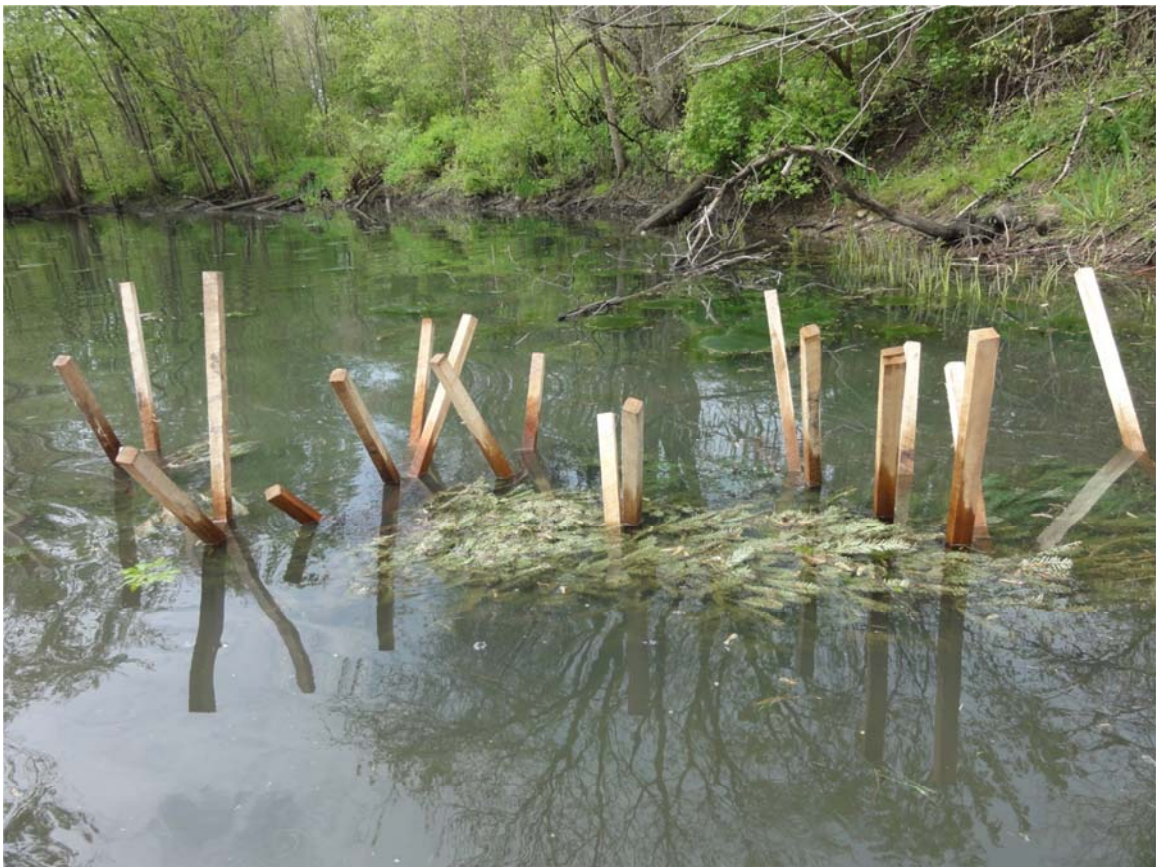
4. MP19.25, installed sediment trap.

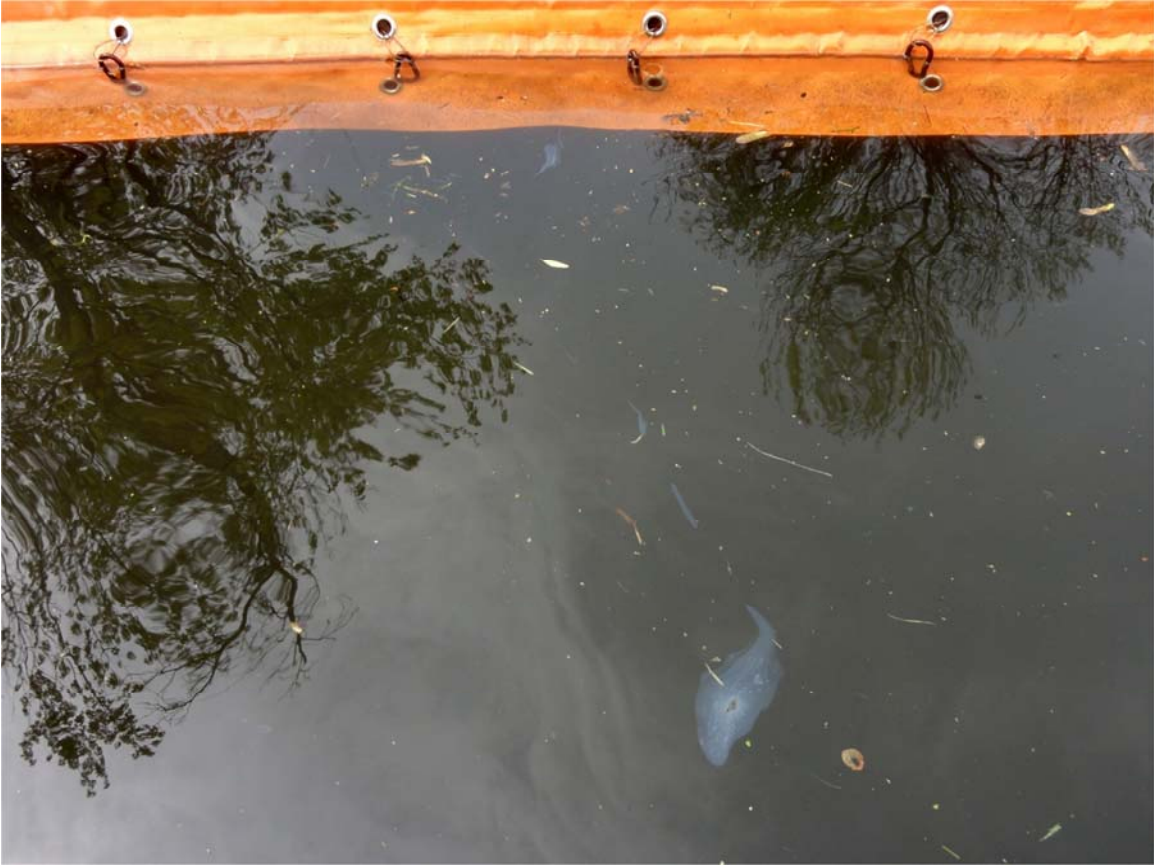
5. MP19.25, sheen observed outside of boom.

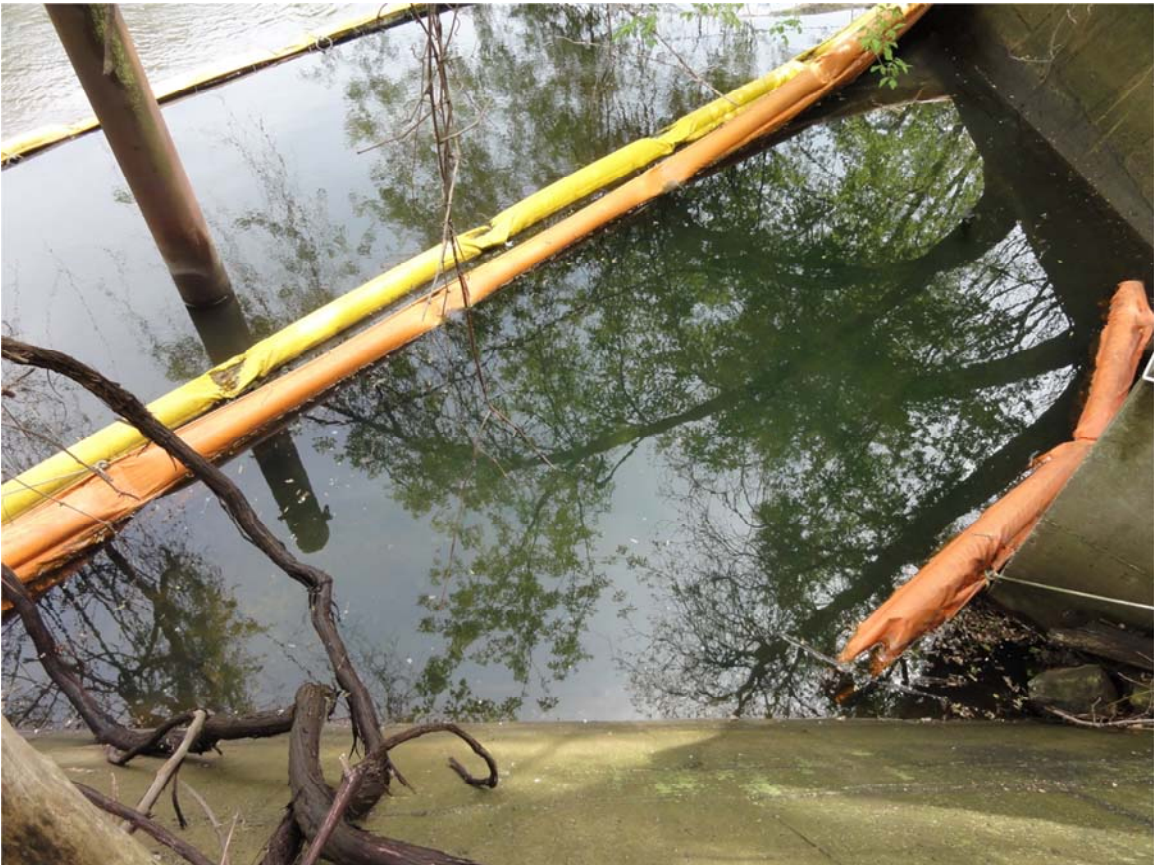
6. Rock Tenn, sheen observed within the boom.

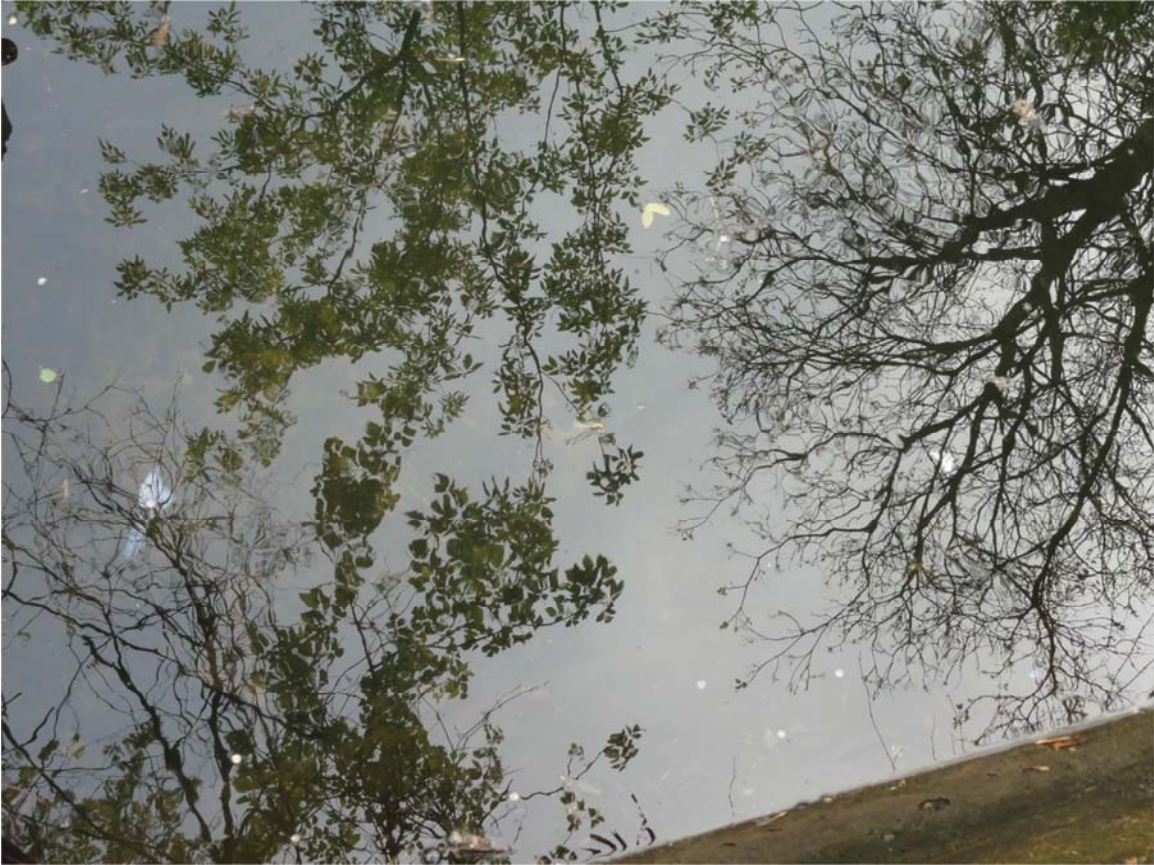
7. Rock Tenn, sheen observed within the boom.

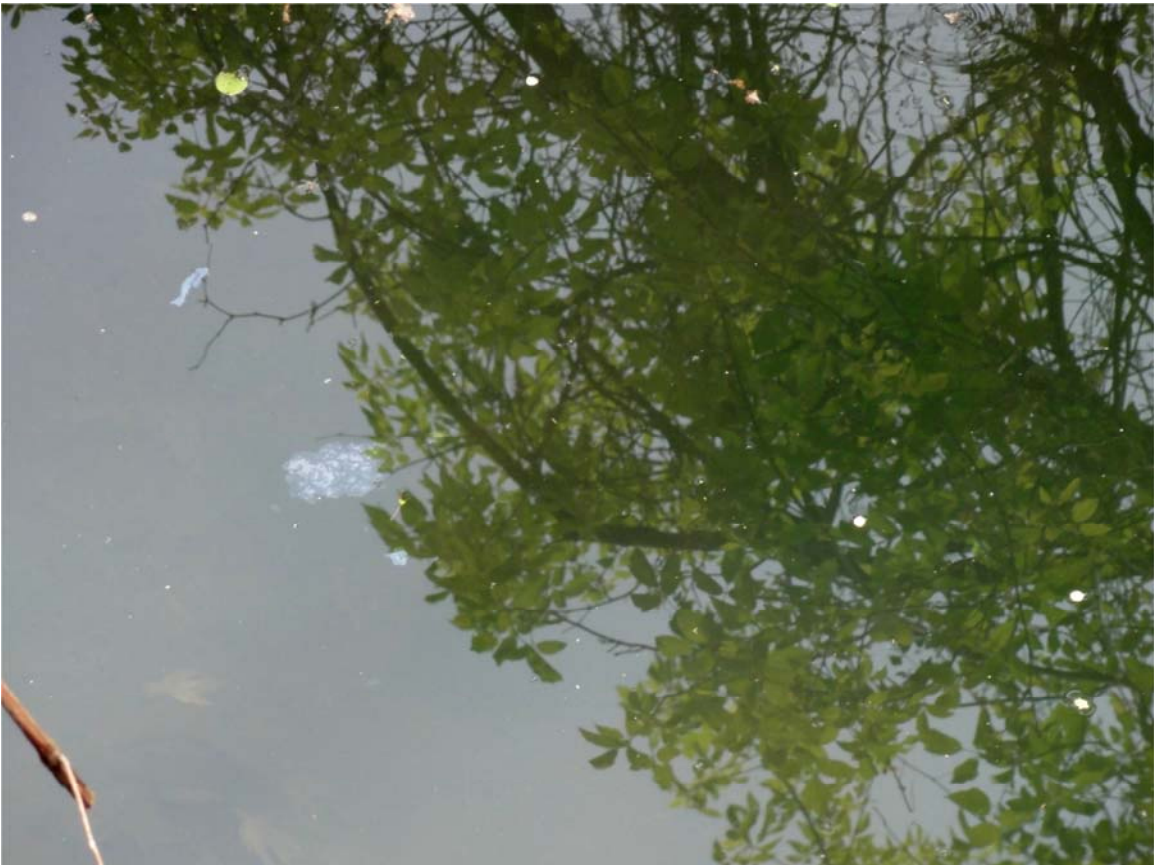
8. Rock Tenn, sheen observed within the boom.

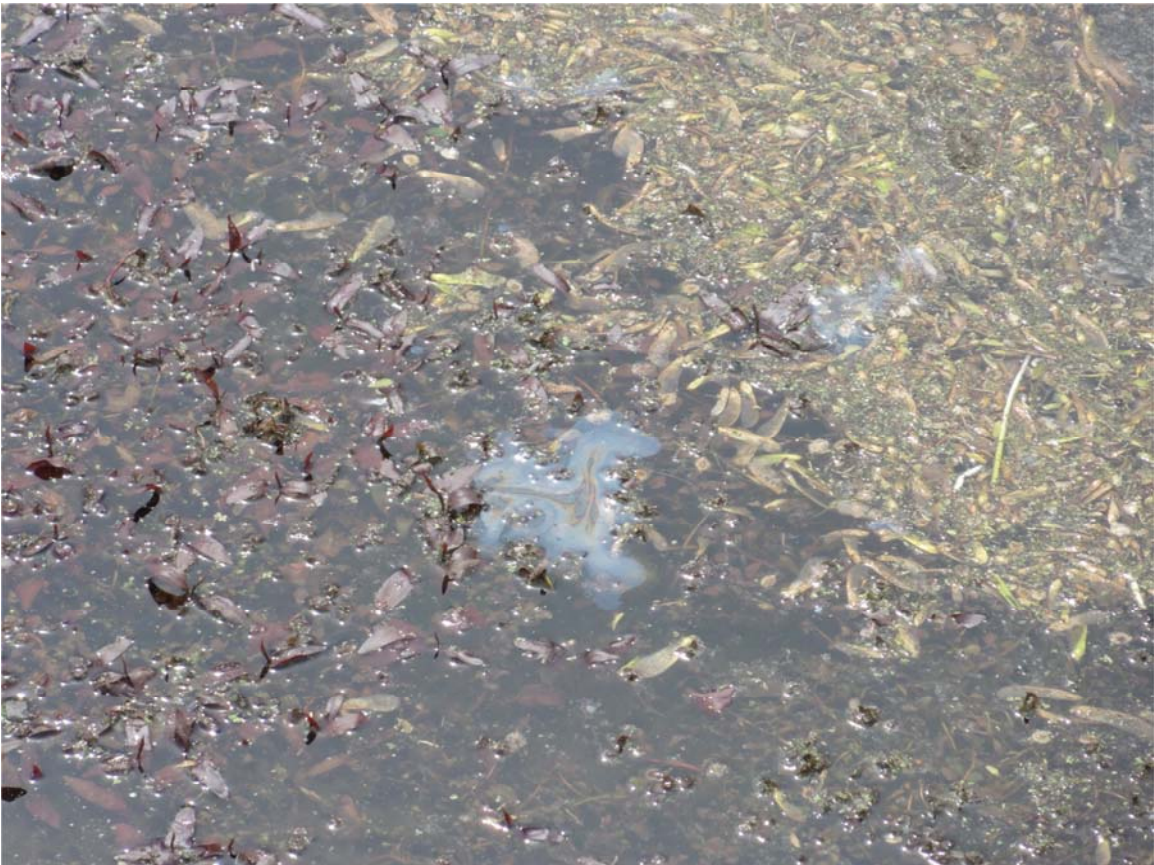
10. MP15.75 sheen observed within boom.

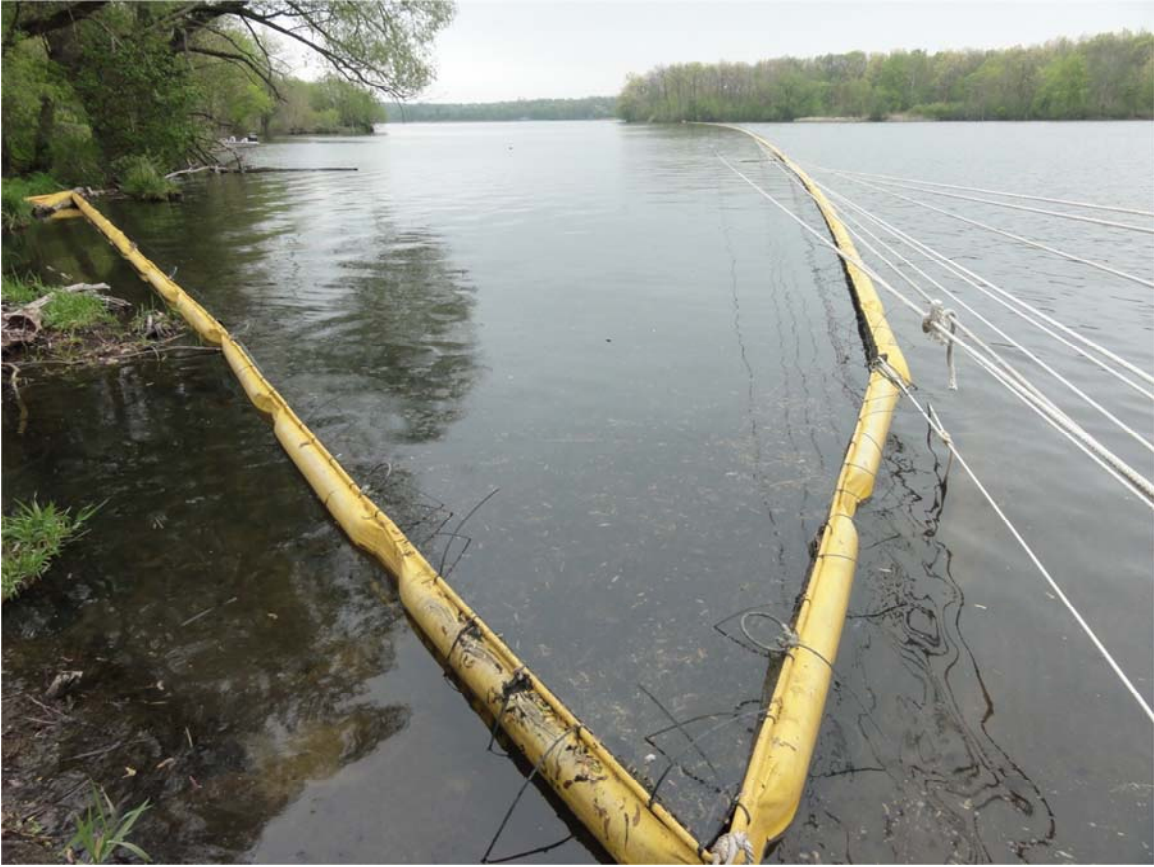
11. E4 Control Point, no sheen observed within the boom.

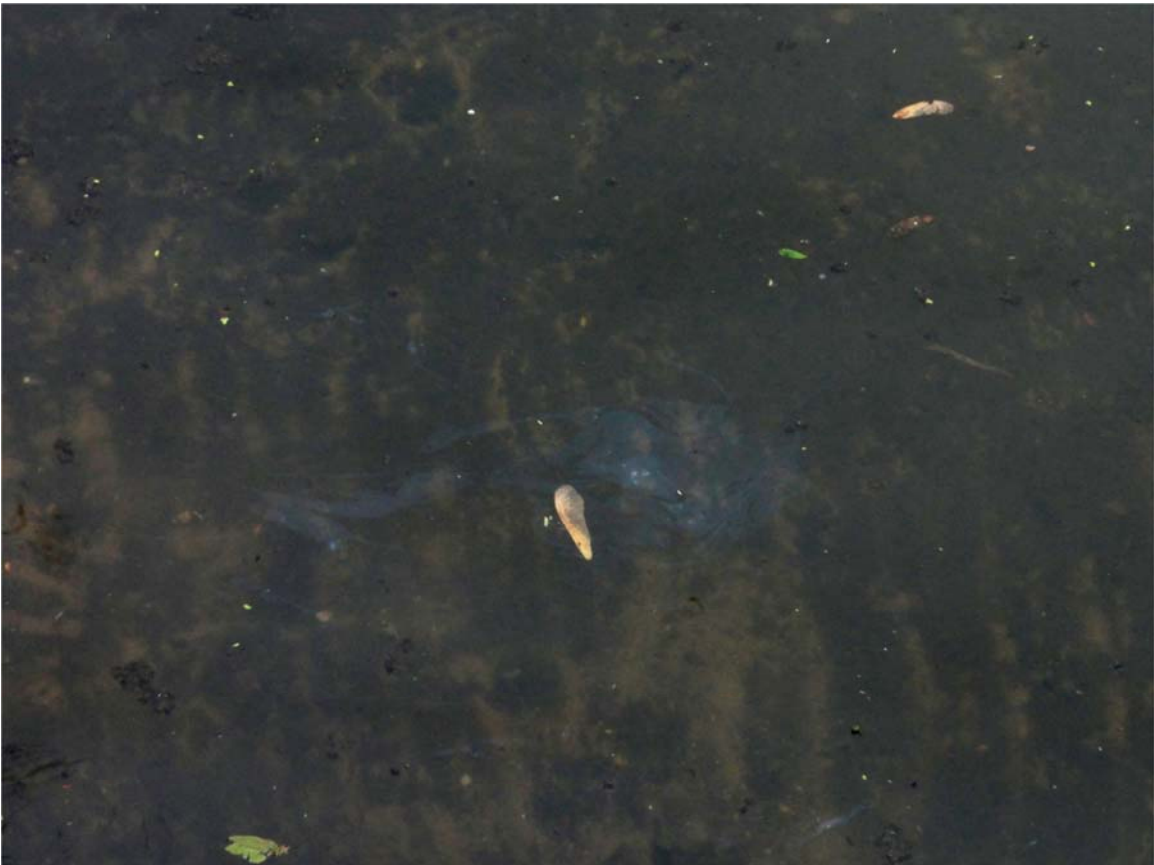
12. Sheen observed downstream of the E4 boom.

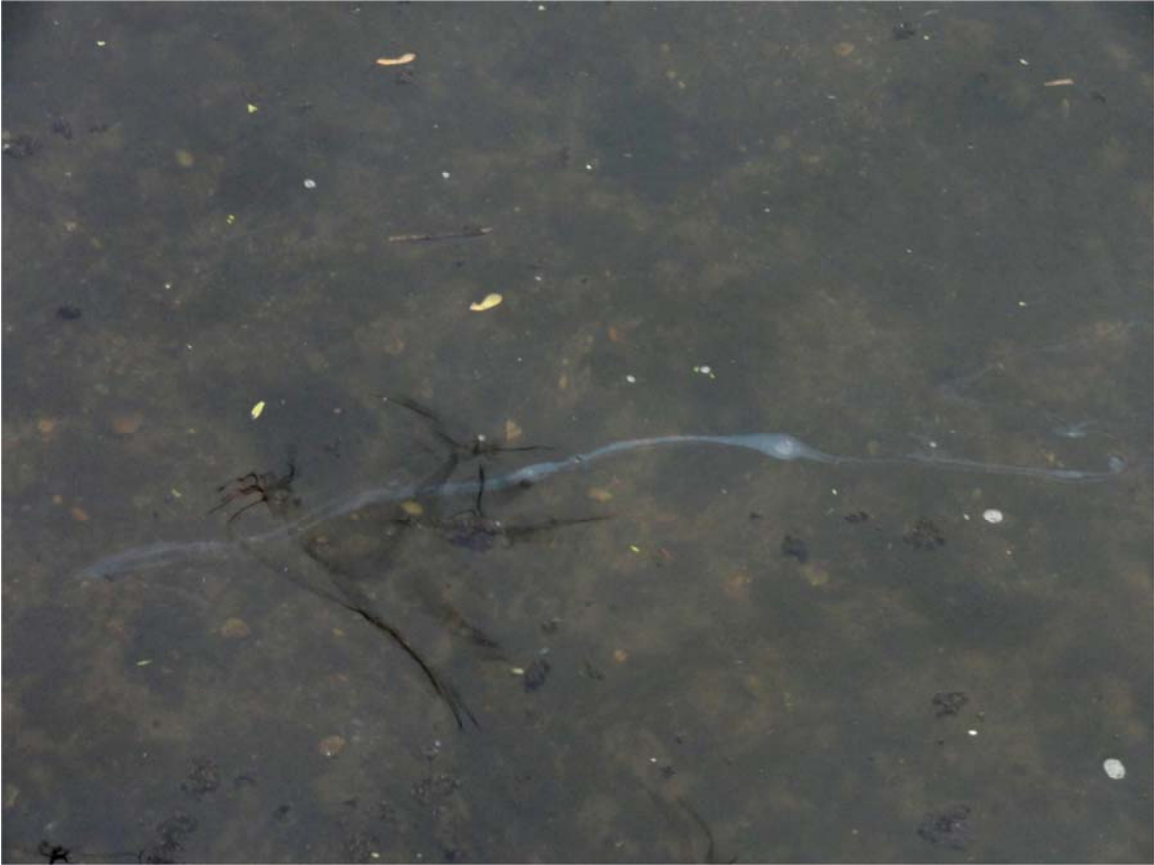
13. Sheen observed downstream of the E4 boom.

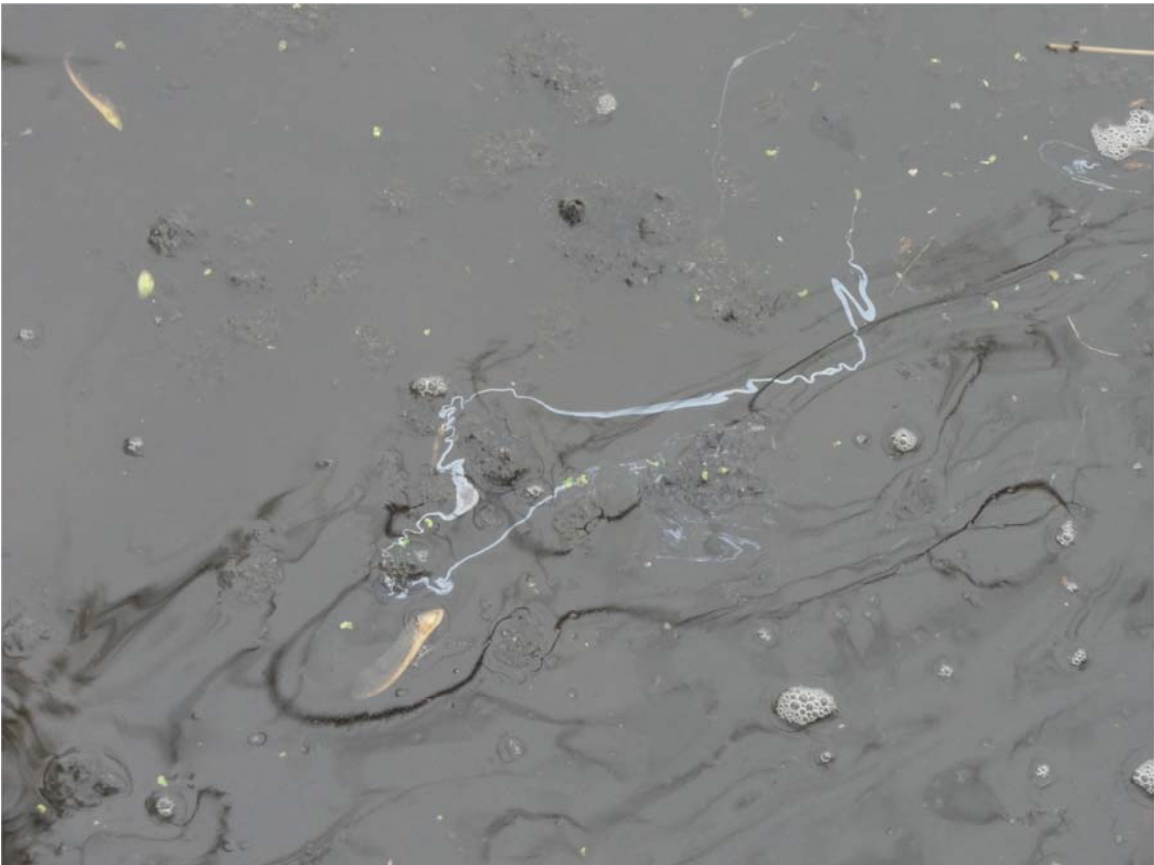
14. Sheen observed downstream of the E4 boom.

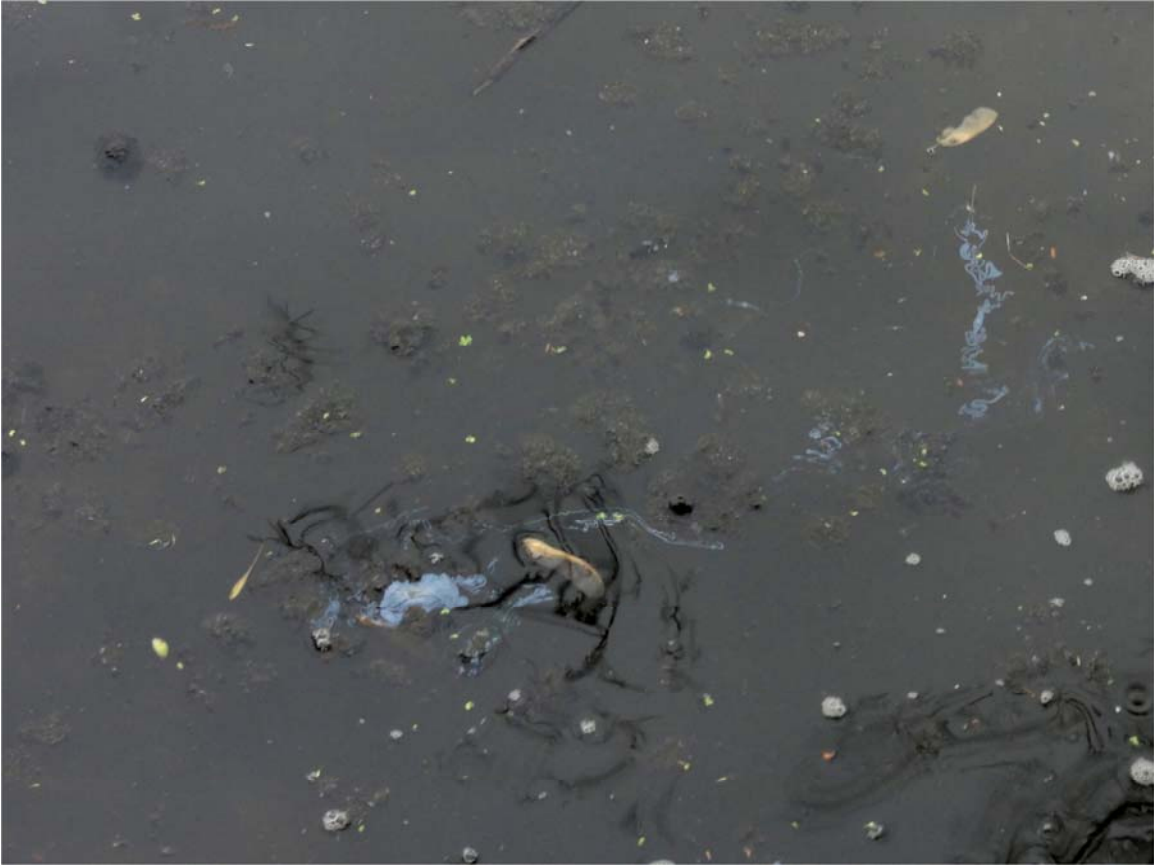
15. Sheen observed downstream of the E4 boom.

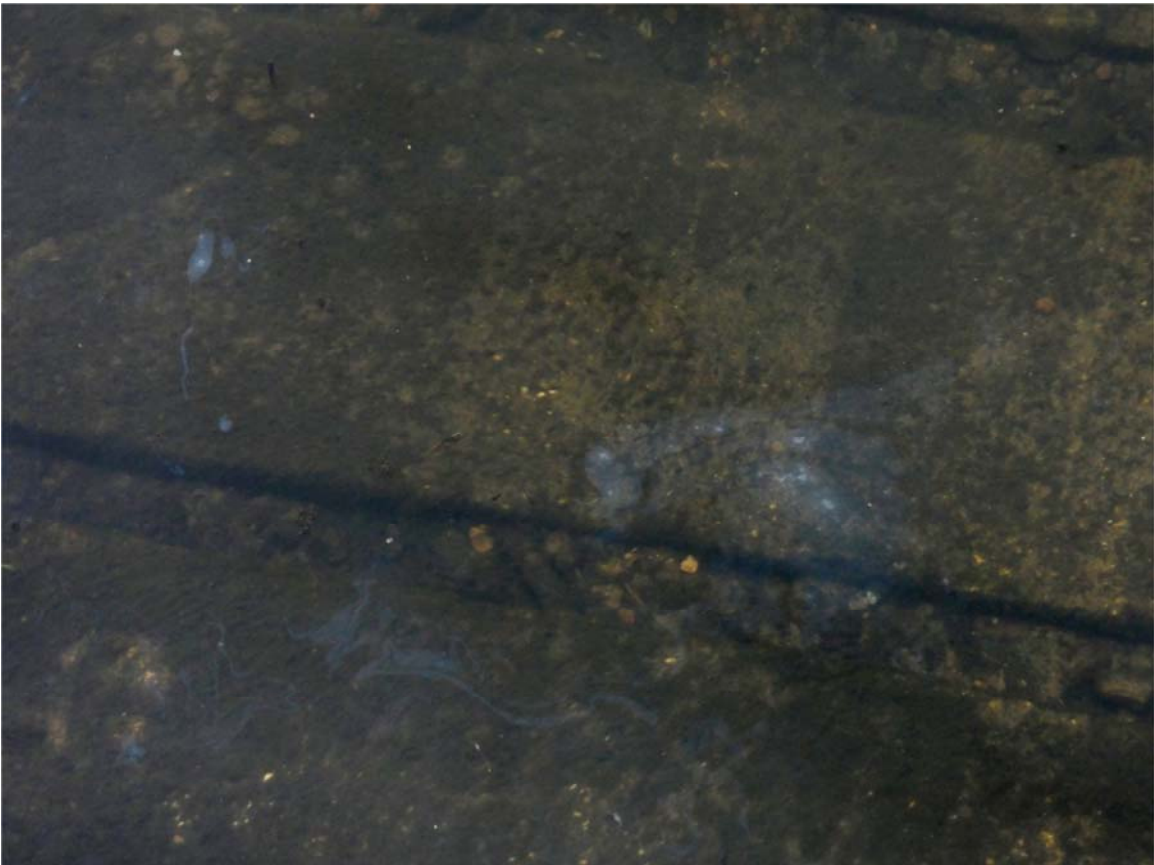
16. Sheen observed at the E4 boat launch

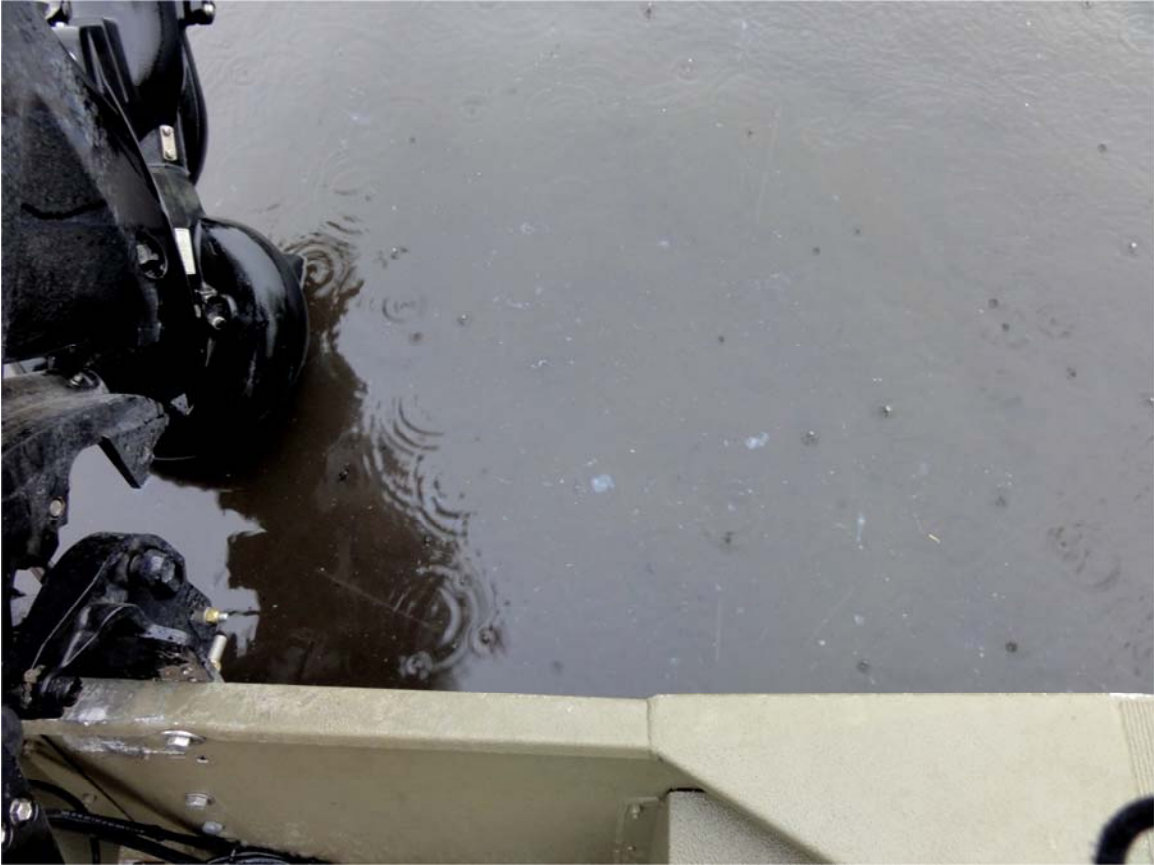
17. Sheen observed at E3 boat launch, sheen appeared when the boat agitated the sediment.

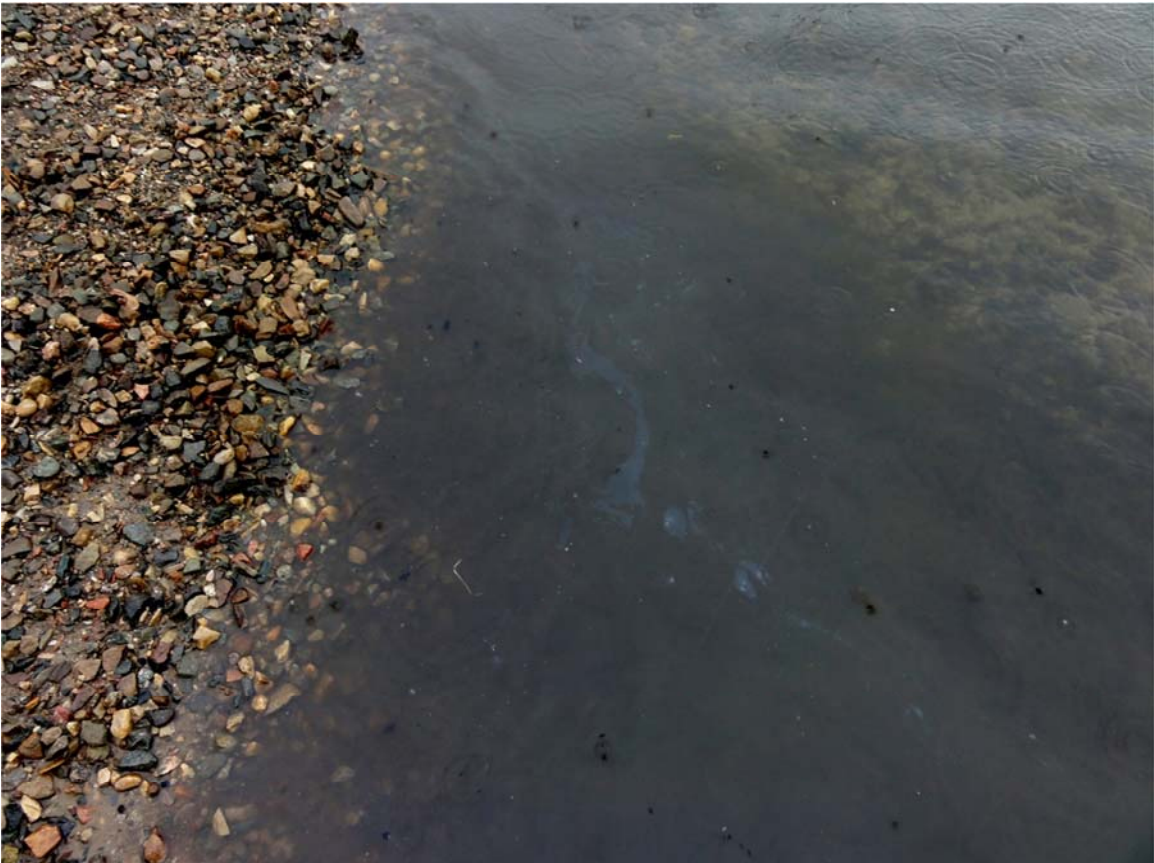
18. Sheen observed at E3 boat launch, sheen appeared when the boat agitated the sediment.

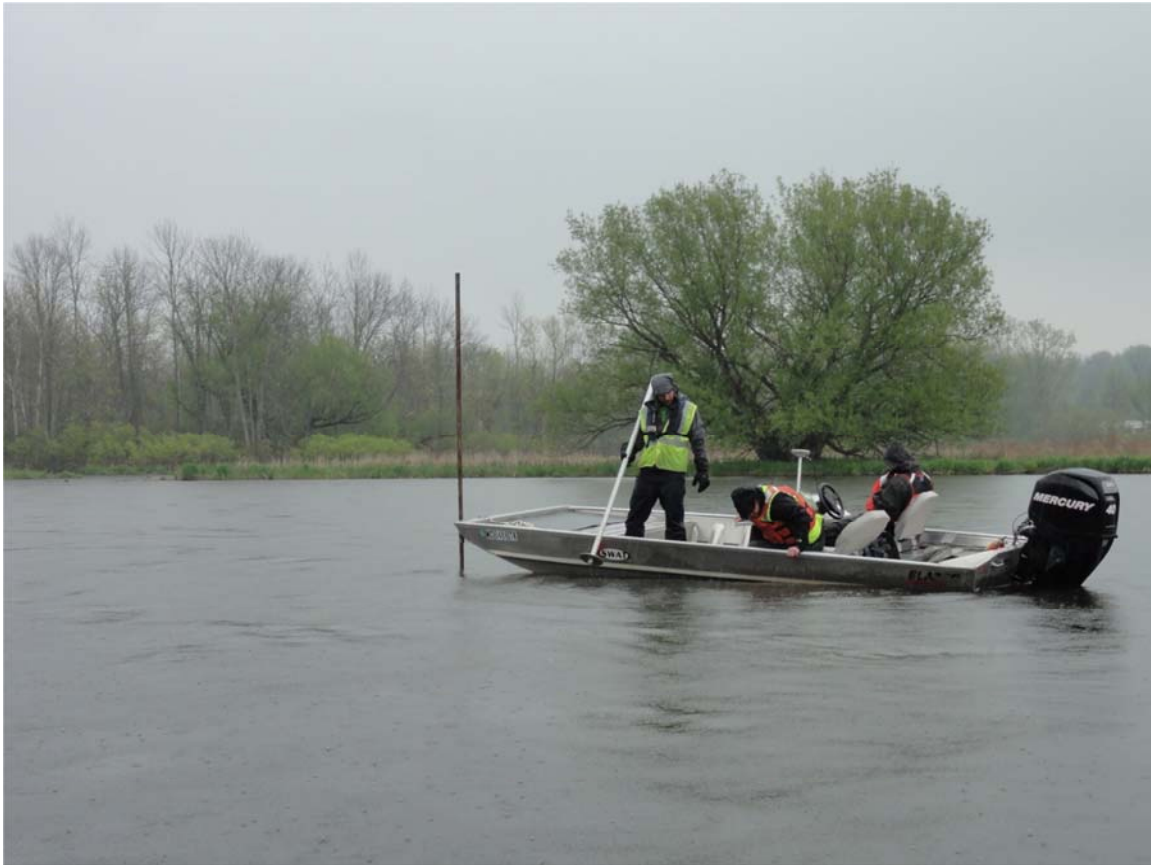
19. Crew poling in Morrow Lake Delta.

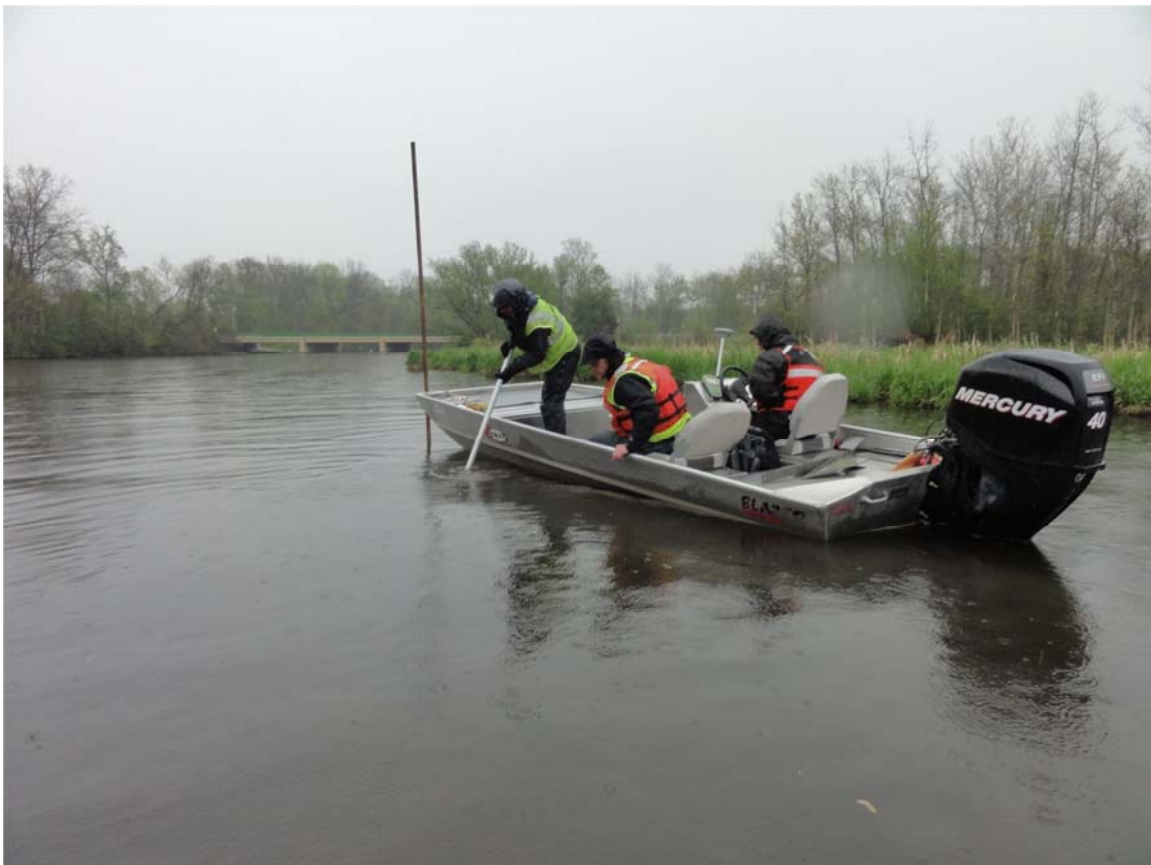
20. Crew poling in Morrow Lake Delta.

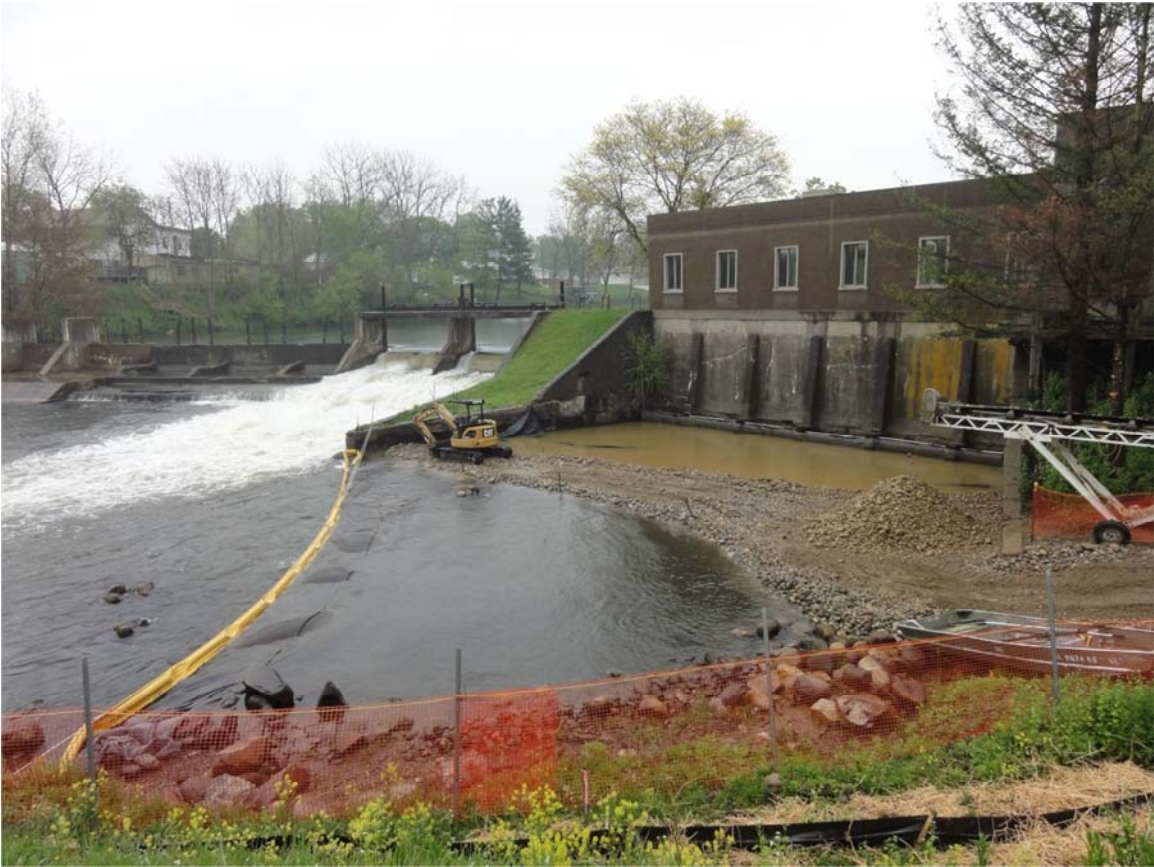
21. Legacy work continuing at Ceresco Dam.

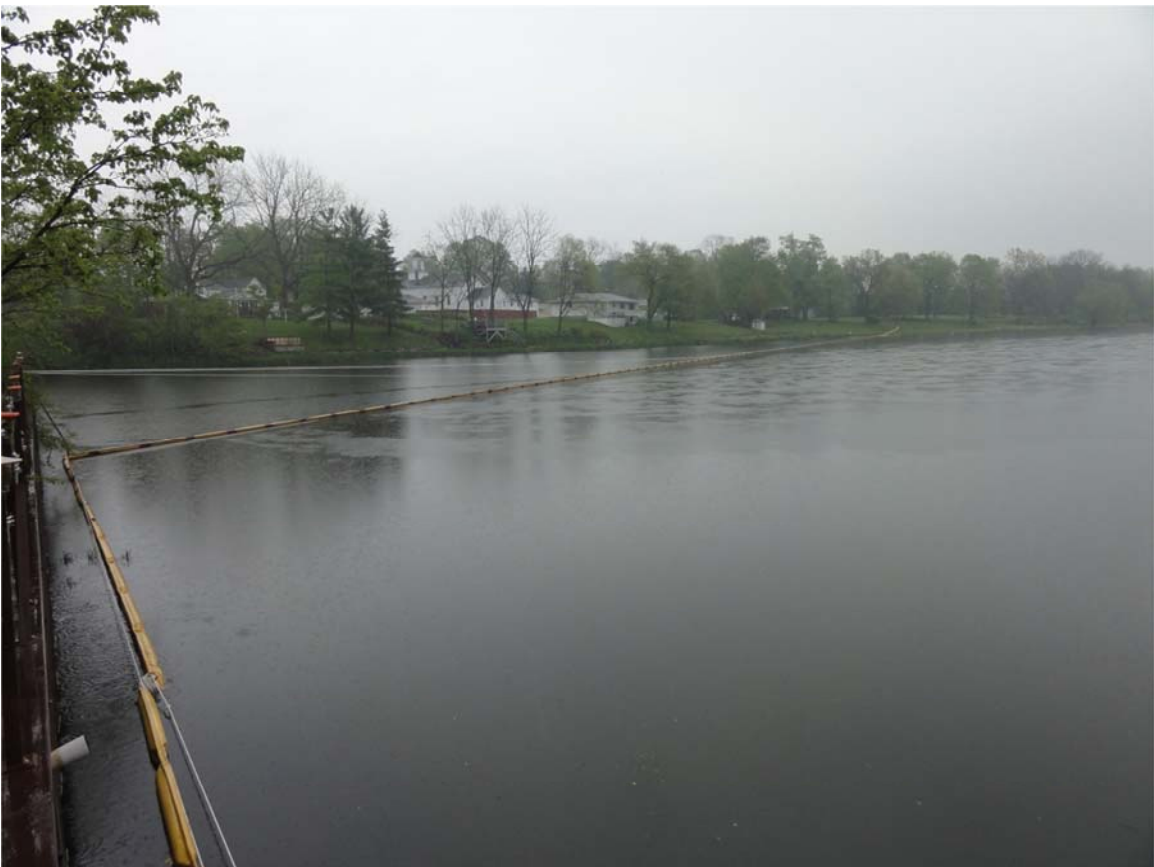
22. Boom reconfigured at Ceresco Dam.

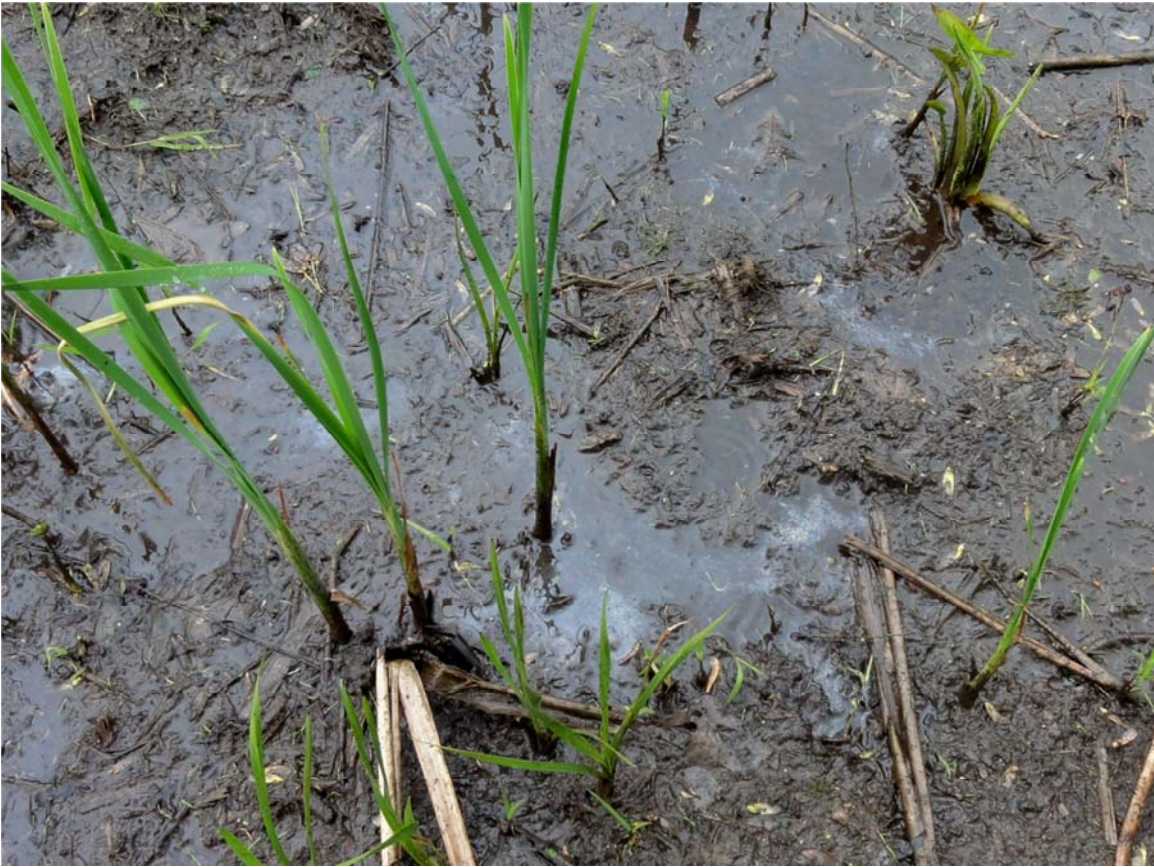
23. Confluence sheen observed.

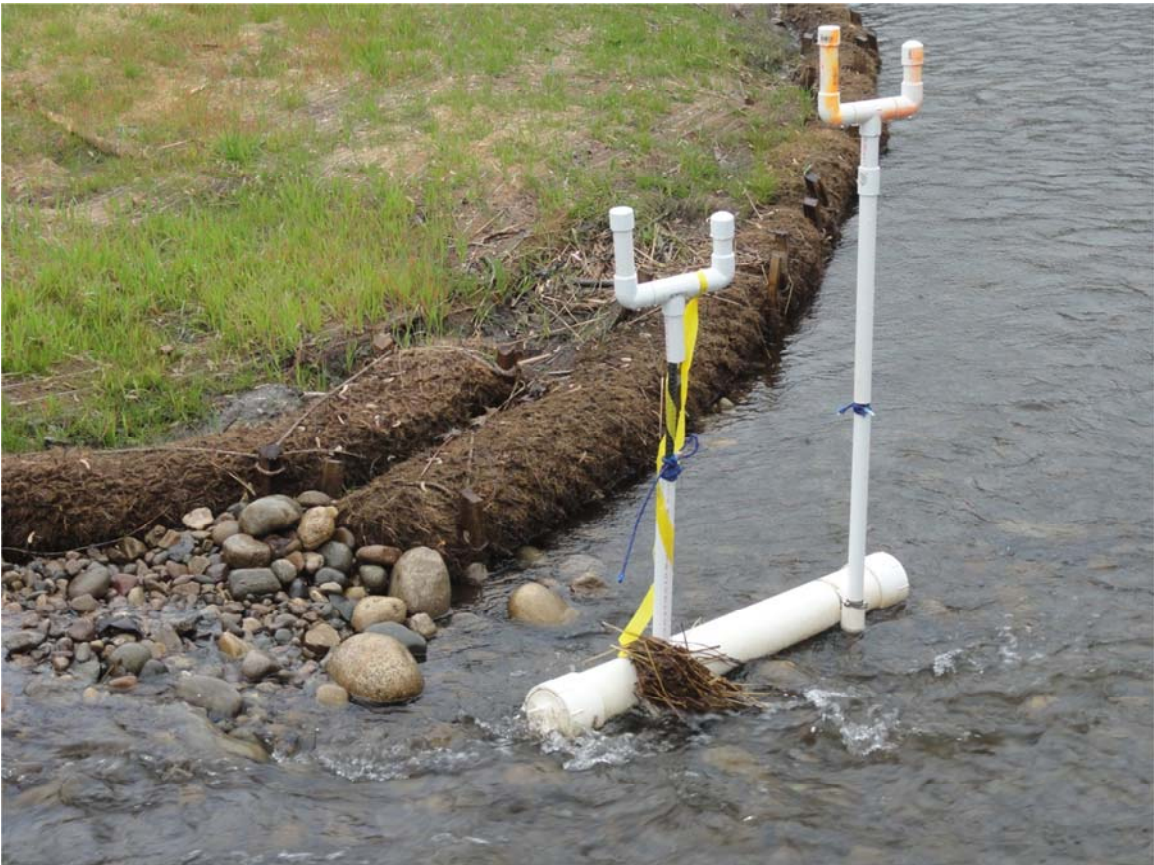
24. Walling Tube located within Talmadge creek.
